## SEEN Safety - IRIS 860

## IRIS<sup>™</sup> 860 sensor

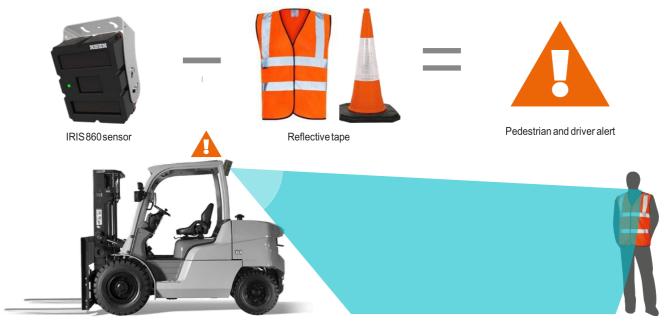
IRIS 860 selectively detects reflective tape on high-vis safety clothing and markers

Pre-set the detection range, up to 8m
